Ground response to high horizontal stresses during longwall retreat and its implications for longwall headgate support

Peter Zhang^{a,*}, Dave Gearhart^a, Mark Van Dyke^a, Daniel Su^a, Essie Esterhuizen^a, Berk Tulu^b

^a NIOSH, Pittsburgh Mining Research Division (PMRD), Pittsburgh, PA 15236, USA

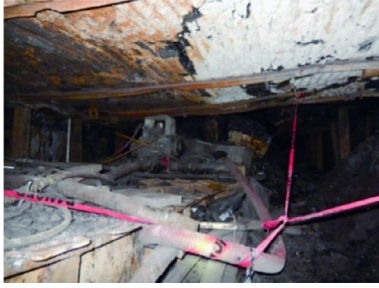
Fig. 4. Roof condition outby the second roof fall in the belt entry.

rate reduced from about 6–9 to 1.5–3 m/day due to operational issues. With a slow advancing rate, the roof cutters propagated to 15–30 cm deep, and the roof sagged 8–10 cm within 15–30 m outby the face. The roof cutters and sagging later became so severe that a second roof fall occurred in the belt entry near the face about 15 m inby the intersection corner (Fig. 1). Fig. 4 shows the roof condition outby the second roof fall in the belt entry.

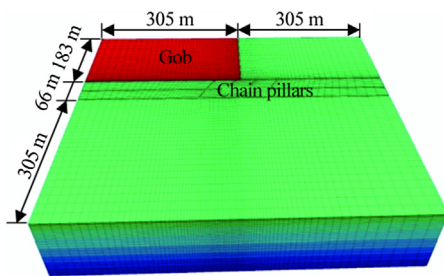
Fig. 5. 3D view of the model at the coal seam level.

ment and longwall retreating. The modeled overburden depth was 213 m. The headgate area, with a gob dimension of 183 m × 305 m, was modeled to simulate a 357 m wide panel. Fig. 5 shows the 3-D view of the model at the coal seam level. The full-scale model extends 122 m below the coal seam and 213 m above the coal seam to the surface. The overburden strata was modeled by ubiquitous joint material, and the rock lithology in the overburden was obtained from the closest corehole to the instrumentation site. The roof geology in the immediate roof was obtained from the scope hole at the instrumentation site. Bedding planes between different rock types were modeled by interfaces. Table 1 shows the rock properties used in the model. The Mohr-Coulomb failure criterion was used for the coal pillar, immediate roof, and floor. The gob was modeled by strain-hardening material implemented by the FISH scripting language available in FLAC3D. The details about implementation of the gob material in FLAC3D can be found in Tulu et al. [10]. Horizontal stresses were applied to the model by a major and minor horizontal-to-vertical stress ratio of 3 and 2, respectively. The entire model consisted of about 1,000,000 elements and 62 interfaces.

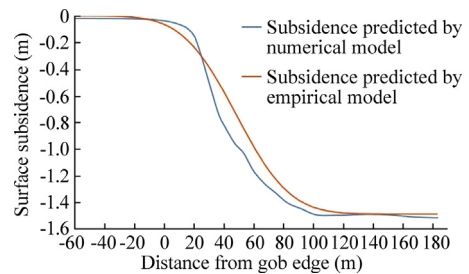
Fig. 6. Surface subsidence predicted by numerical and empirical models.

Surface subsidence and measured vertical stress in the pillars were used for numerical model validation. To validate the numerical model for reasonable overburden movement, the surface subsidence predicted by the numerical model was compared to the surface subsidence predicted by an empirical subsidence model CISPM-W [14]. Fig. 6 shows the final surface subsidence profiles predicted by both the numerical and empirical models. By comparison, the surface subsidence predicted by the two models agrees reasonably well. Under a mining height of 2.3 m, both models predicted 1.5 m of maximum subsidence around the center of the panel and 6.1–9.1 cm of subsidence at the edge of the panel.

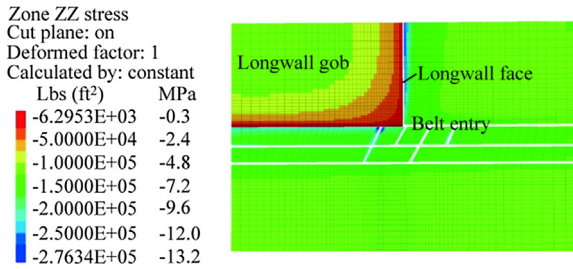
Fig. 7. Vertical stress distribution over the headgate area.

Fig. 7 shows the vertical stress distribution around the headgate area of the longwall panel under 213 m of overburden depth. The maximum abutment pressure is 13.1 MPa, about 2.5 times the vertical stress. The vertical pressure change in the pillars measured by borehole pressure cells (BPCs) are compared to the vertical stress in the pillars from the model. Fig. 8 shows the vertical stress distribution across the chain pillars when the instrumentation site is at a different position in respect to face location. The BPC readings are

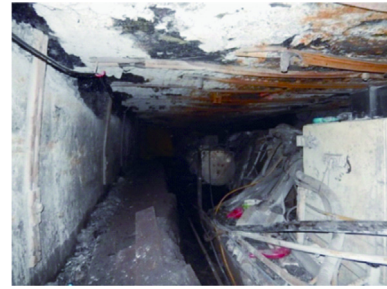
Fig. 9. Cutters developed at entry corners near the face.

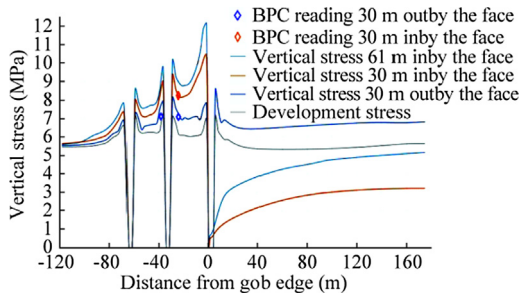
Fig. 8. Vertical stress across the gate entries.

plotted in Fig. 8, which shows that the measured pressure in the pillars fits well with the abutment pressure distributions obtained from the model.

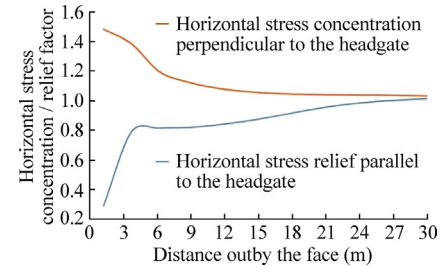
Fig. 10. Horizontal stress concentration and relief along the belt entry 3 m above the roofline.

The horizontal stress change in the belt entry within 30 m outby the face is investigated in the numerical model. Fig. 10 shows the horizontal stress concentration and relief 3 m above the roofline along the belt entry. Fig. 10 clearly indicates a horizon-

tal stress concentration perpendicular to the entry and relaxation parallel to the entry within 30 m outby the face. The majority of the horizontal stress changes occur within about 15 m outby the face. Within 9 m outby the face, the horizontal stress increases by 10%–50% perpendicular to the entry but reduces by 20%–80% parallel to the entry. These horizontal stress changes make contributions to the roof instability of the belt entry as evidenced by the roof sagging and cutters that occurred in the study panel. The elevated horizontal stress perpendicular to the entry could result in roof sagging, whereas the relaxation of the horizontal stress along the entry could reduce confining pressure and induce tensile stress in the immediate roof. This unfavorable stress environment is present in the belt entry within 9 m outby the face, where almost all the roof falls occurred during longwall retreating. Although the vertical stress is also concentrated in the area, roof falls seem more likely to occur where the horizontal stress is concentrated.

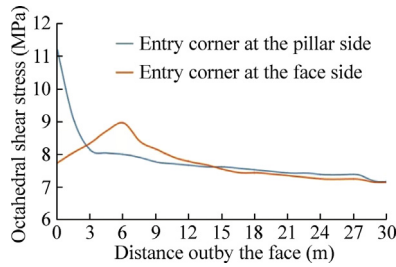
Fig. 11. Octahedral shear stress at the belt entry corner 1 m above the roofline.

As roof cutters are observed at the entry corner within about 1 m of the roofline in the belt entry, the octahedral shear stress at the same location is examined in the model. Fig. 11 shows the octahedral shear stress 1 m above the roofline in the belt entry corners. Fig. 11 shows that the octahedral shear stresses on both sides of the entry are elevated within 30 m outby the face with the majority of the shear stress increase occurring within 15 m outby the face. The extent of the shear stress increase from the model is strongly correlated with the extent and severity of roof cutters observed in the belt entry outby the face.

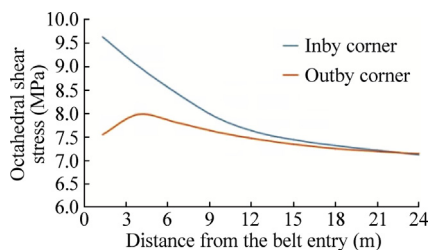
Fig. 13. Octahedral shear stress along the length of the crosscut 1 m above the roofline when the face is 15 m from the intersection.

in the crosscuts within 9–15 m of the belt entry when the face was within about 15 m from the intersection. The cutter at the inby corner was more severe than at the outby corner of the crosscut. Fig. 12 shows the cutter developed at the inby corner of the crosscut. The octahedral shear stresses at the crosscut corners are examined in the model. Fig. 13 shows the octahedral shear stress along the length of the crosscut 1 m above the roofline when the face is 15 m from the intersection. Fig. 13 shows that the octahedral shear stresses on both sides of the crosscut increase within about 15 m from the belt entry, but the shear stress at the inby corner is higher than that at the outby corner of the crosscut. The extent of the shear stress increase from the model is also strongly correlated with the extent and severity of roof cutters observed in the crosscuts of the study panel.

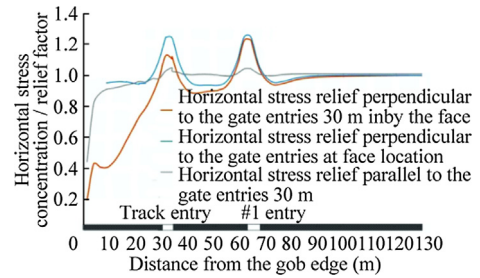
Fig. 14. Horizontal stress concentration and relief factors over the chain pillars.

The horizontal stress concentration and relief in the roof over the chain pillars at different face locations are obtained from the model. Fig. 14 shows horizontal stress concentration and relief 3 m in the roof over the chain pillars. Fig. 14 shows the horizontal stress changes both parallel and perpendicular to the gate entries.

There is almost no horizontal stress change in the roof parallel to the panel retreat direction in the track entry and #1 entry. However, the horizontal stress in the roof perpendicular to the panel retreat direction relieves inby the face. The horizontal stress relief in the roof above the track entry is less than 5% at face location, but increases to about 10% 30 m inby the face. This may explain why the roof movements measured by the extensometers in the track entry at the instrumentation site were greatly reduced when the face was 15 m outby the site. One possible reason is that the horizontal stress across the track entry began to relax 15 m inby the face, thus preventing further roof movements. The horizontal stress relief zone across the chain pillars is within 61 m from the gob edge. The #1 entry, which is 66 m away from the gob, is not influenced by horizontal stress change. It should be noted that the small horizontal stress peaks are caused by the effect of entry excavation.

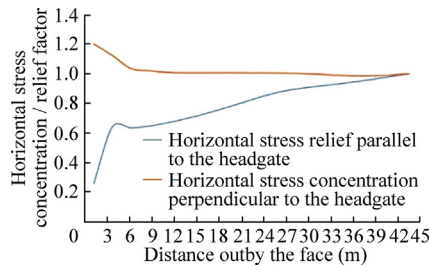
Fig. 15. Horizontal stress concentration along the belt entry 3 m above the roofline in a left-handed panel.

Fig. 15 shows the horizontal stress concentration 3 m above the roofline along the belt entry in the left-handed panel. Fig. 15 indicates that horizontal stress concentration perpendicular to the belt entry is significantly lower than in the right-handed panel.

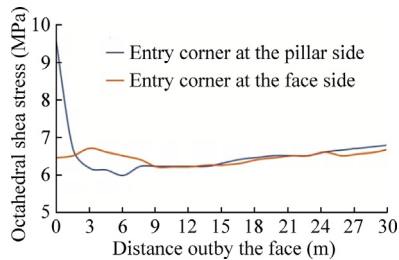
Fig. 16. Octahedral shear stress at the belt entry corner 1 m above the roofline in a left-handed panel.

Fig. 16 shows the octahedral shear stress 1 m above the roofline at the belt entry corner in a left-handed panel. The octahedral shear stress at the belt entry corner is also significantly lower than in the right-handed panel. The difference in octahedral shear stress is caused by the horizontal stress abutment in the right-handed panel and horizontal stress relaxation in the left-handed panel. The higher octahedral shear stress concentration at the belt entry corners explains why cutters are more likely to occur in the belt entry in the right-handed panel.
